The Importance of Bloodstain Pattern Analysis in the Investigation of Road Traffic Accidents: A Case Report

We present a case study of a road traffic accident in which bloodstain pattern analysis helped us to solve the discrepancy between reports produced by forensic examiners and by the forensic biology department.

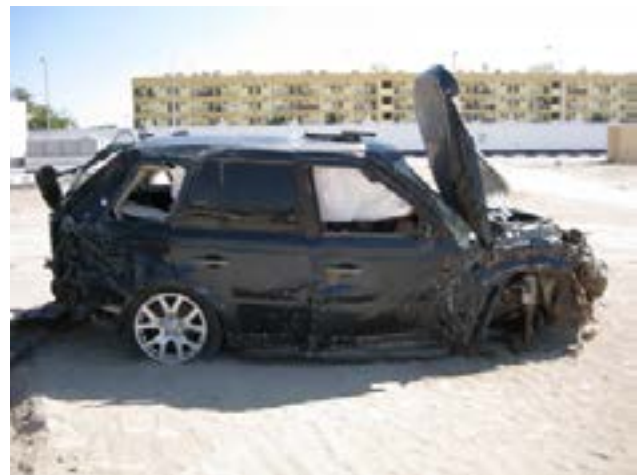
Figure 1- The 4 Wheel car with collision of the front and rear.

The car was inspected by the forensic examiner and at examination time the car was moved from the scene of the accident to the Forensic Department at Dubai Police Headquarters. The car showed signs of collision at the front reaching the front windshield. The front windshield was cracked but was still in place. The rear of the car, including the rear windshield, also showed signs of collision (Figure 1).

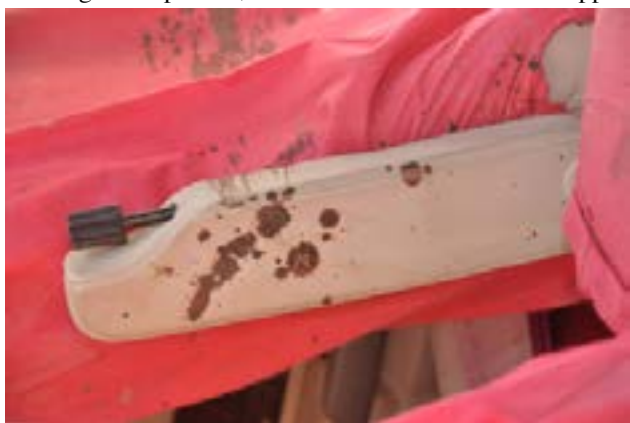
Figure 2- Bloodstains on the handrest of the driver's seat.

Bloodstains found on the armrest of the driver's side as well as on the driver's seat were analyzed. On the armrest of the driver's seat, there were a few stains, which were circular in shape (Figure 2).

The armrest of the driver's seat had a beige color leather cover. The bloodstains deposited on the armrest were circular in shape with a formation of symmetrical spines at the margins indicating that the blood source was perpendicular (Figure 2). The formation of satellites around the drops, which were more obvious at areas overlapping the drops, also indicates that the blood dripped from a perpendicular source for some time and that the source of blood dripped down onto the surface from above. This confirms the testimony of the woman that the overturned car came to rest on its left side. If the car had come to rest in an upright position, the blood stains deposited in the car would have exhibited a downwards directionality.

Satellites can form due to impact spatter patterns; however, in this case, the majority of satellites did not surround the circles. This was due to a second drop of blood dripping onto a blood pattern formed by an initial drop of blood. The resulting splash and increased blood volume in that area caused the satellites to form around the area of the overlap between the first blood drop and the second drop. Moreover, in this case, the bloodstains on the seat and on the armrest were lacking standard criteria-the distribution was not radial, as in an impact pattern, nor was it linear as in a cast off pattern. In addition, all the stains on the armrest and the seat were in a defined area and at the same level. This indicates that the source of bleeding for all of the blood stains on both positions was from the same source and from the right side [3,6,8,14,15].

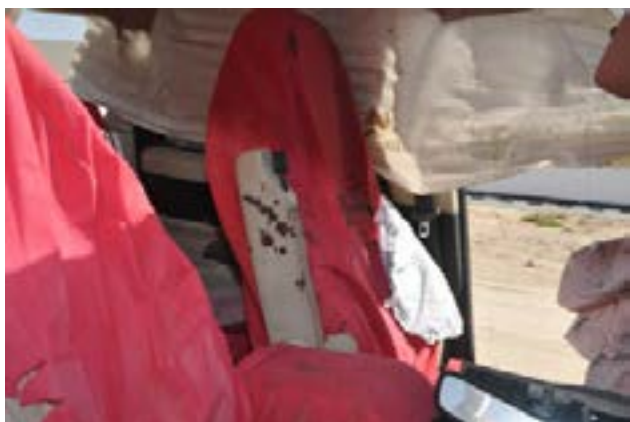
Figure 3- Bloodstains on the driver's seat.

The red cover of the driver's seat was folded vertically forming a symmetrical bloodstain pattern with two faces on either side. The face on the right side had some bloodstains in the middle (Figure 3).

In the case presented here, the blood deposited on the driver's seat was on synthetic absorbent surface, which absorbed the blood on it (Figure 3). Caution should be taken in such cases when interpreting and classifying bloodstain patterns on a synthetic absorbent surfaces [12,14]. The synthetic material on the seat had a vertical fold bulging outside and dividing the bloodstain on the cover into a pattern with two faces on either side; the face which was on the right side also had some bloodstains in the middle (Figure 3). The bloodstains were at the same level as the bloodstains on the armrest of the driver's side and exhibited an absorbed pattern. Some of the stains showed spines at the left side. The bloodstains stopped sharply at the margin of the vertical line and this could only have occurred if the blood source was from the right side. Some flow pattern was observed with directionality towards the left side, which also indicated that the source of the blood was from the right side of the seat. Moreover, the position of the source of the blood (deceased driver in this case), and the surface of the car seat on which the bloodstain deposited, did not change during the accident. These observations supported the woman's statement.

onto the driver's armrest from the passenger's side of the car was from a constant source, forming a flow pattern on the driver's seat. These results, coupled with a DNA analysis of the blood patterns, confirmed the woman's statement that she was sitting in the passenger seat and that the car stood on its left side after turning over.
